## Expert NY Inspections LLC

# KINCAID RESIDENTIAL INSPECTION REPORT

**123 Sample Street**

**1/15/2024 10:00AM**

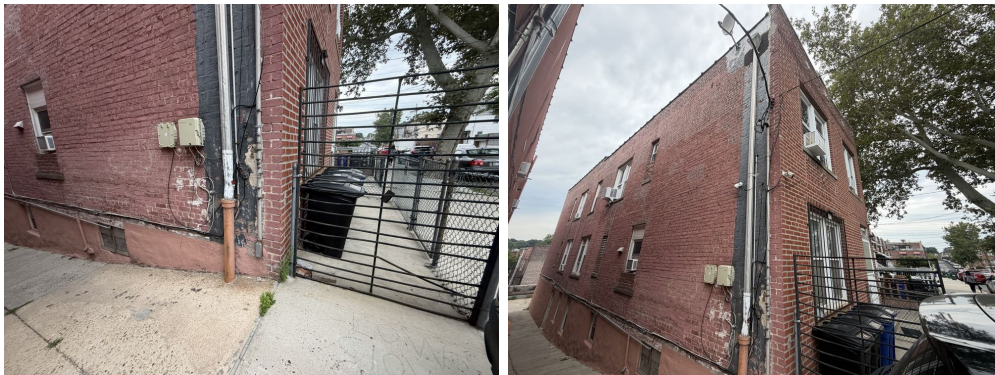
## 2.15 Driveways

### Driveway Material: Concrete

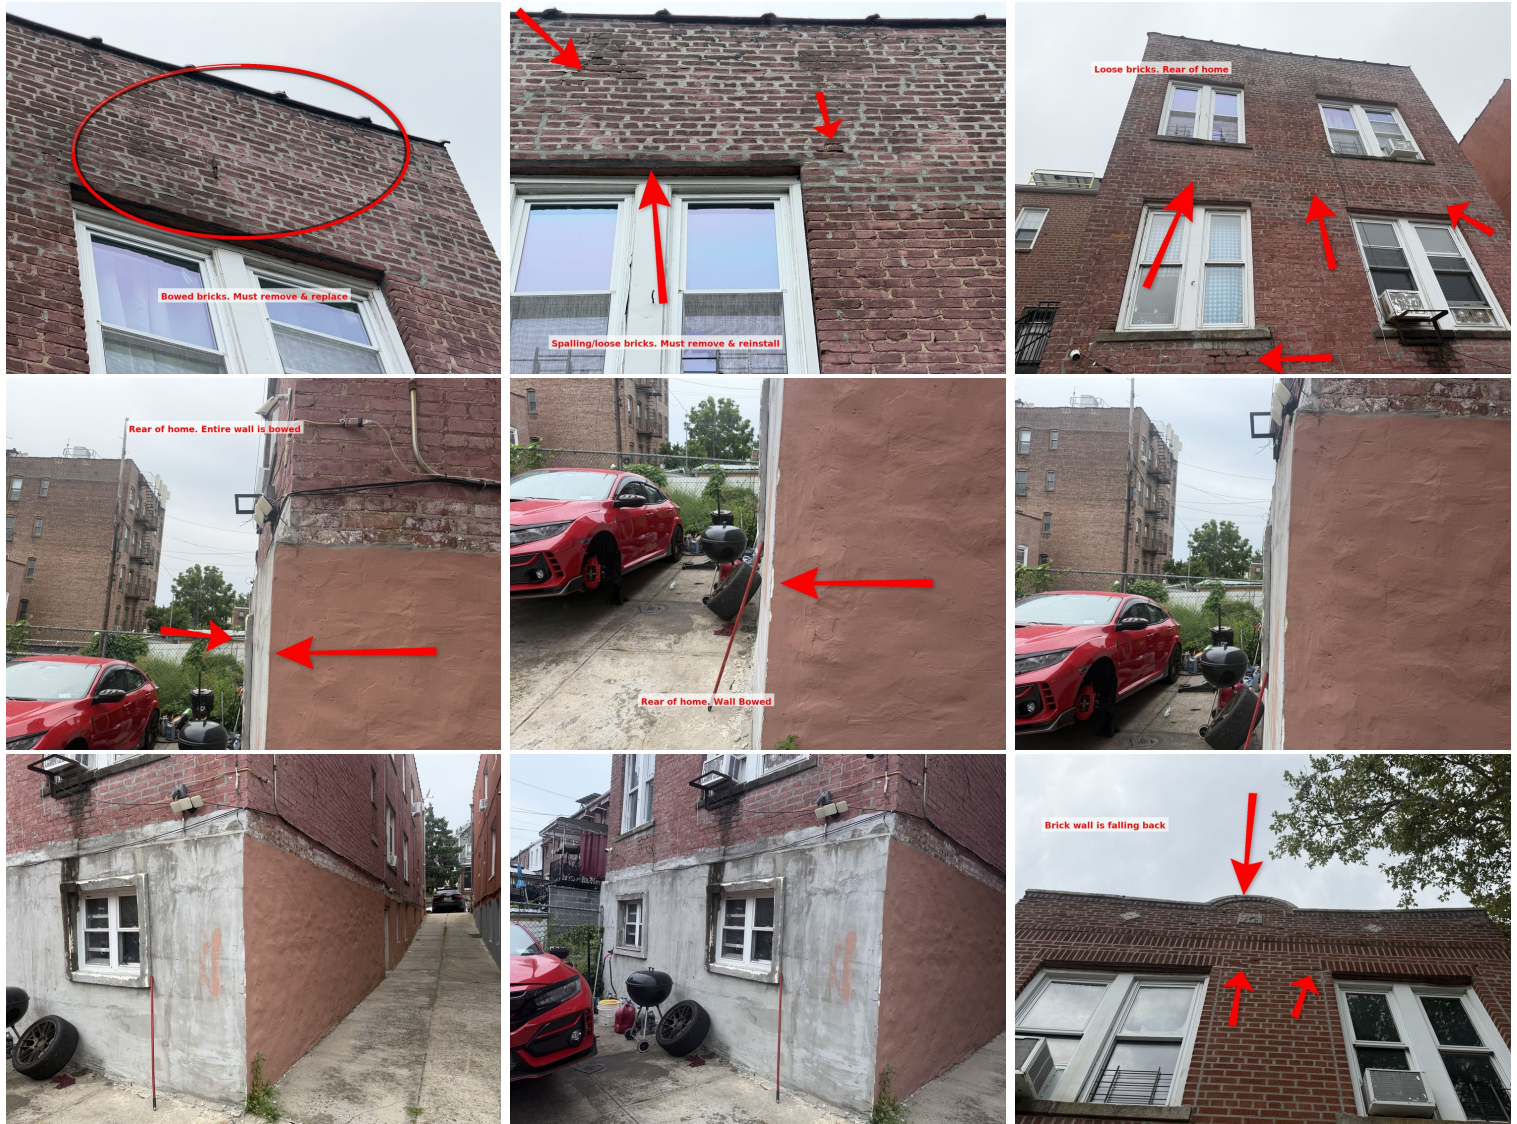
## 2.16 Foundation

### Spalling

Areas of the foundation were observed to have spalling and/or deterioration.

This is often caused by chronic or constant moisture. Freeze/thaw cycles can exacerbate the rate of spalling and cracking.

There were a lot of areas of the home where the bricks were loose & /or falling out. Safety hazard noted. I strongly recommend repair by a qualified foundation contractor. The rear foundation wall of the home was bowed & in danger of falling. Strongly recommend to have a qualified contractor review & replace masonry.

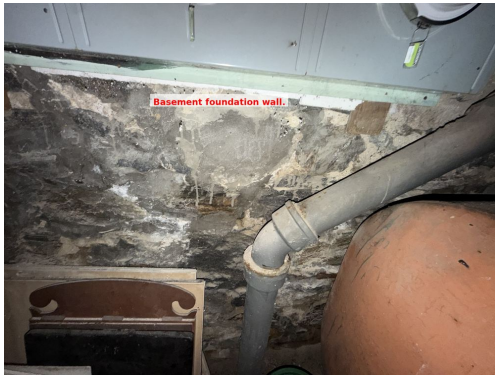
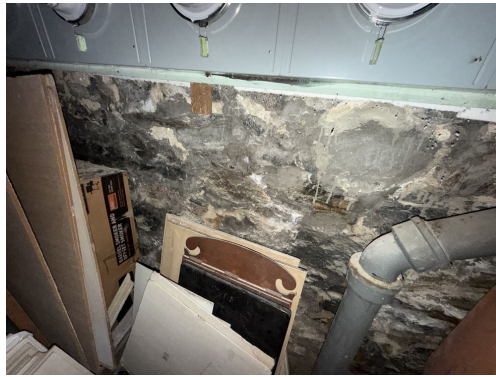
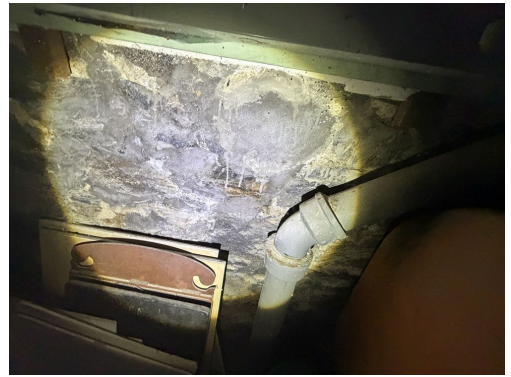
## 2.17 Foundation

### Efflorescence

Efflorescence & crumbling mortar observed on portions of the foundation walls. Recommend to remove all clutter from the basement and re-enforce the stone foundation to the home.

Efflorescence and evidence of moisture intrusion noted on basement surfaces. Efflorescence a white, chalky deposit that is caused by moisture intrusion as water leaches out it's salts and minerals. This can compromise the soil's ability to support the home structure and/or lead to mold growth.

I recommend further evaluation by a qualified contractor to identify the source or cause of the moisture and remediate as deemed necessary.

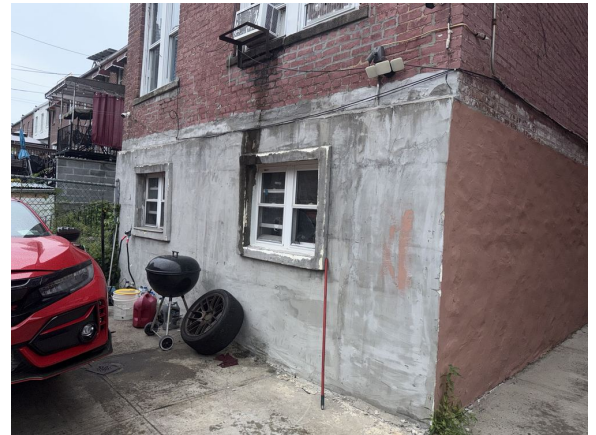
### Inadequate Drainage

Inadequate drainage noted by the back of the home. The driveway is pitched towards the rear of the home without any proper drainage system in place.

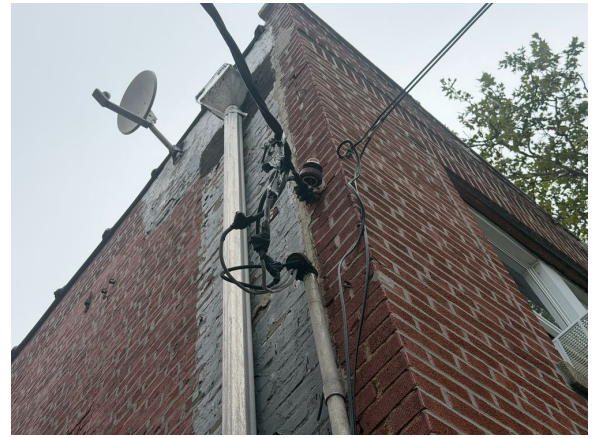
## 2.20 Service Entrance Conductors

### Frayed or Damaged Sheathing

Service entrance conductor sheathing/jacketing was observed to be frayed or unsatisfactory. I recommend contacting your electric utility company or a qualified electrician to evaluate and repair.

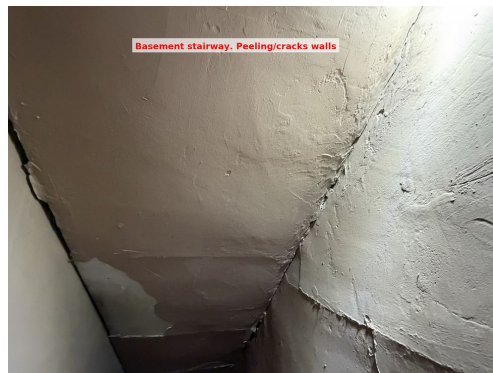
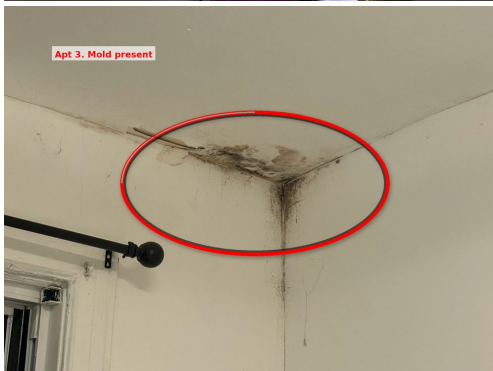
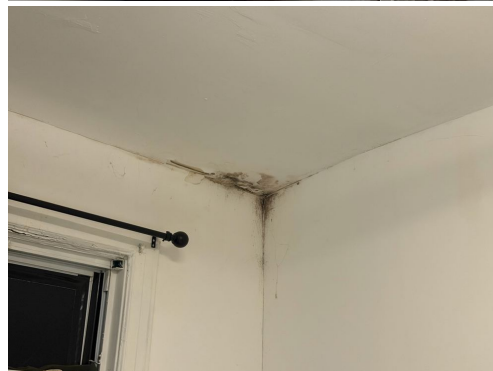
Gaps cracks and/or holes were observed in the walls in one or more areas. Mold present in apartment 3. Lead paint observed throughout - further testing required. Recommend repair & further evaluation by a qualified contractor.

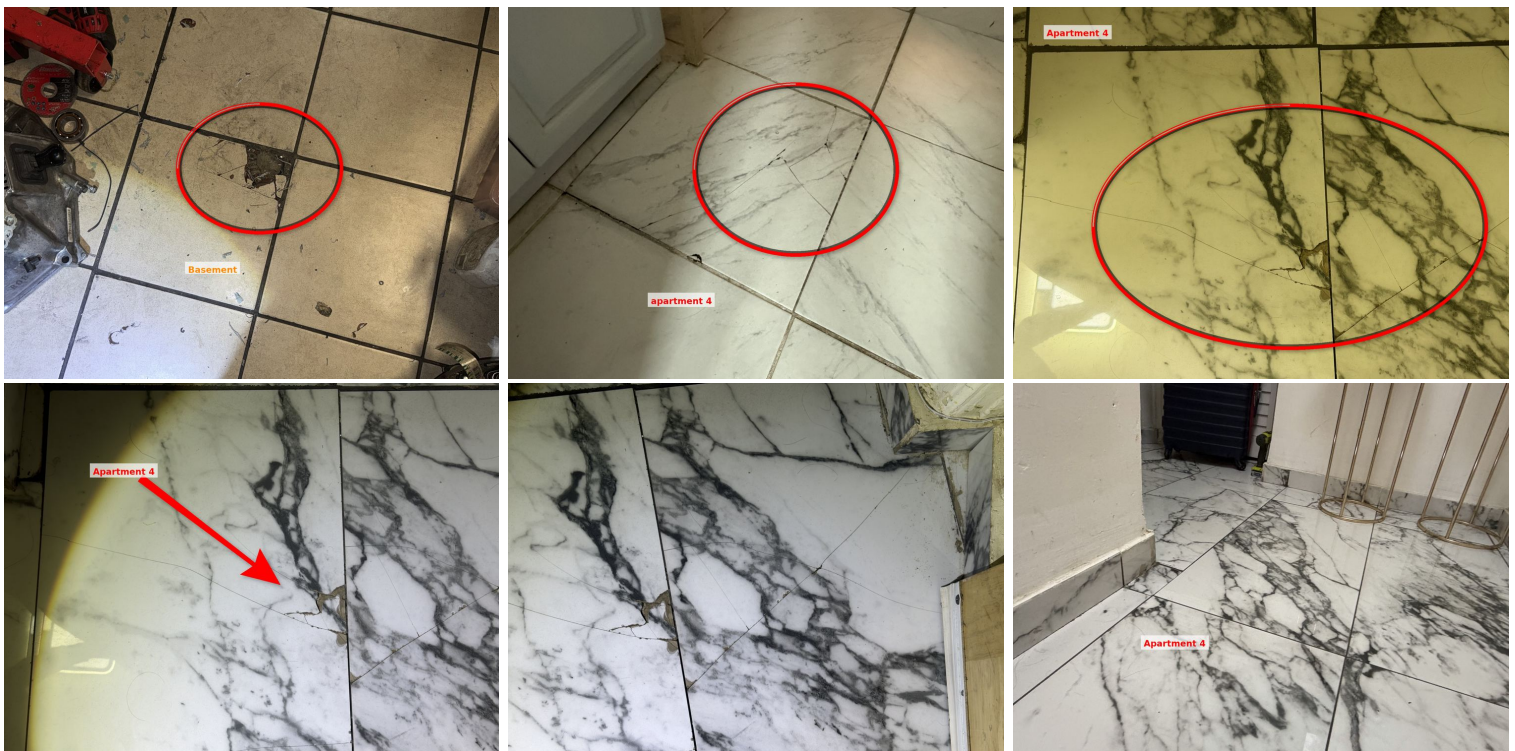
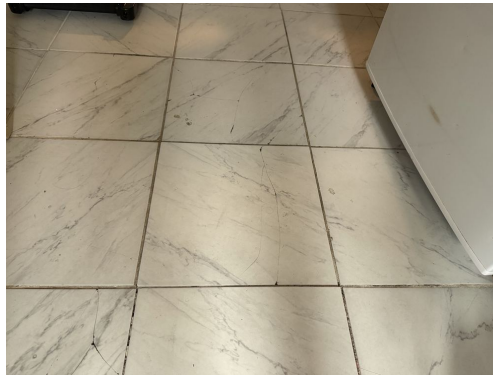
3.20 Floors

**Loose/Cracked Floor Tiles**

Loose and/or cracked floor tiles observed in the basement & apartment 4. I recommend you consult with a qualified tile contractor to discuss options and costs for repair and/or replacement.

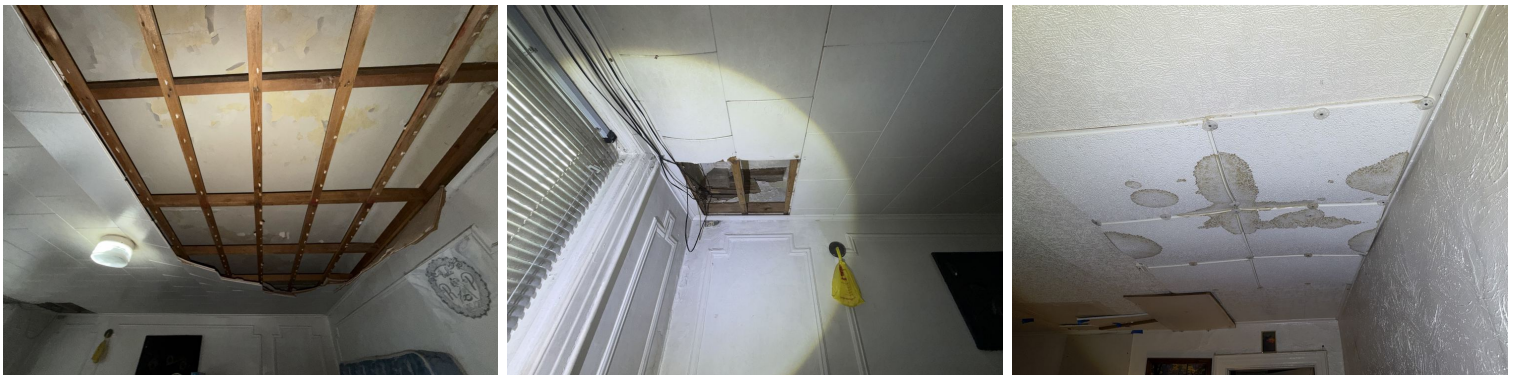
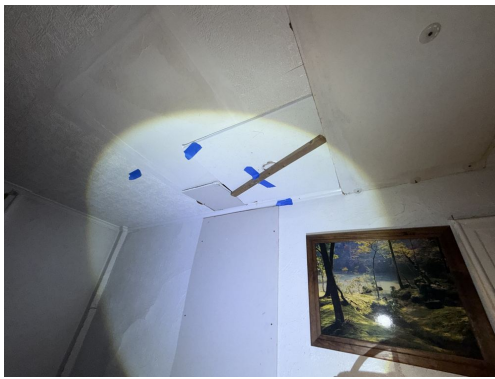
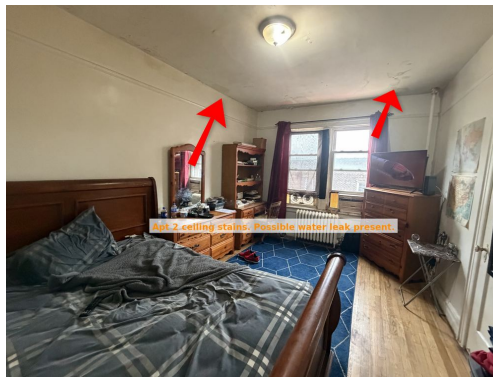
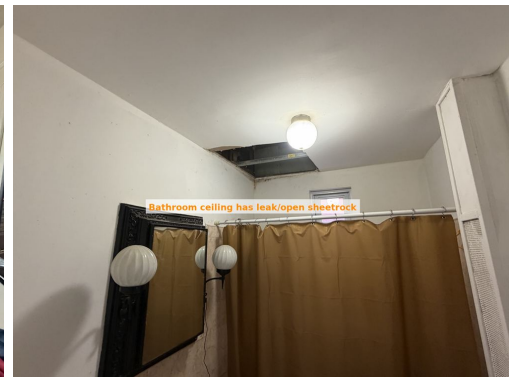
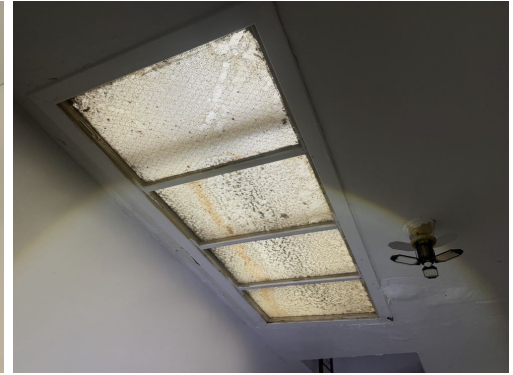
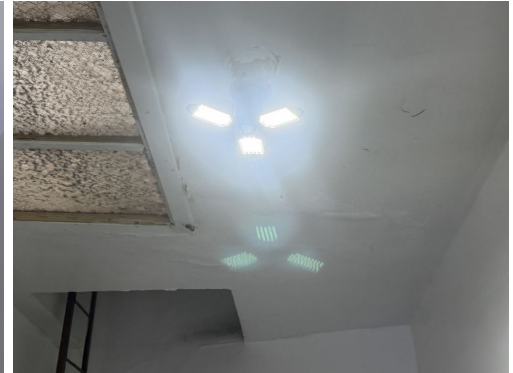
### 3.24 Ceilings

#### Stain(s) on Ceiling

There is a stain on ceiling/wall that requires repair and paint in apartment 1, 2, & basement & 2fl hallway. Source of staining is from water leaks, poor maintenance & crumbling ceilings.

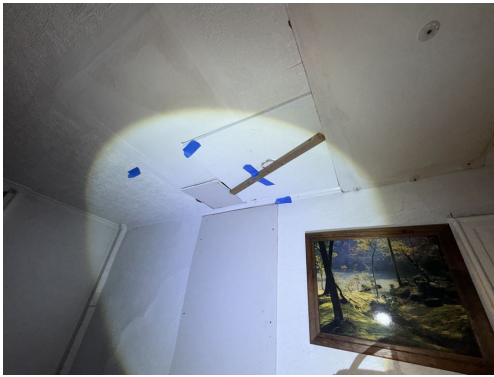
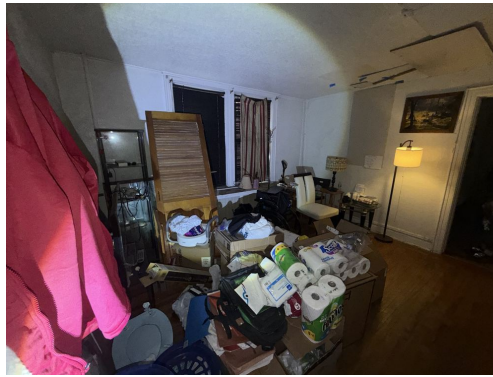
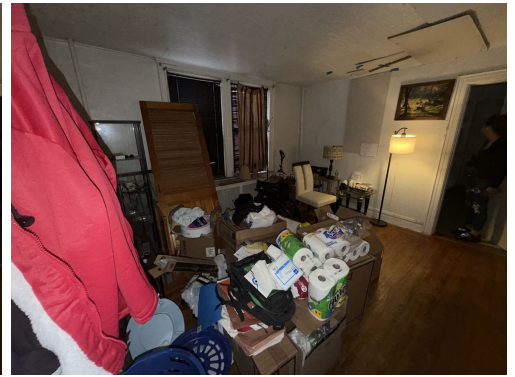
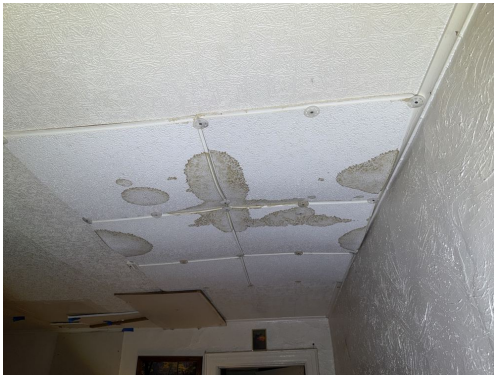
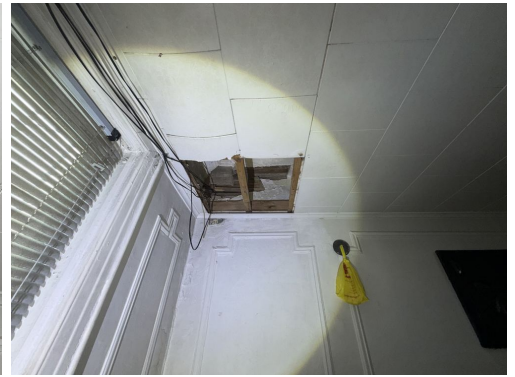
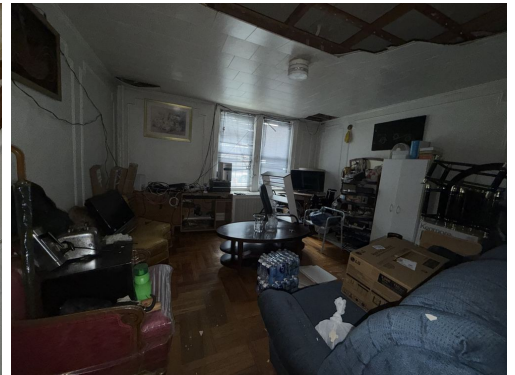
### 3.25 Ceilings

#### Broken Ceiling Tiles

One or more ceiling tiles or observe to be cracked and or broken. I recommend to remove panels & ceiling. Make needed repairs & install new sheetrock.

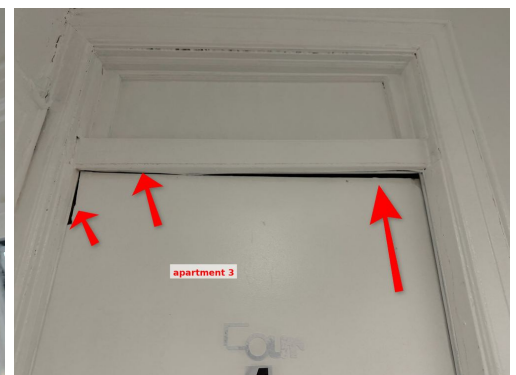
Racked Door Frame

The framing of one or more door frames was observed to not be properly aligned, square and plumb. Racking appeared to be due to structural movement and/or settlement of the structure.

I recommend consulting with a general contractor who specializes in re-leveling antique homes or a structural engineer to establish a corrective action plan.

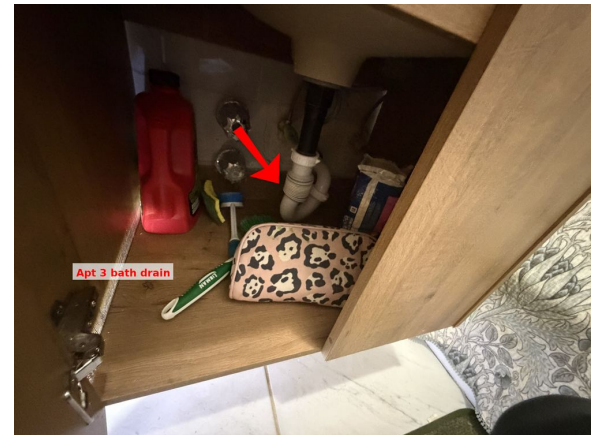
A flex Drain was observed under one or more sinks. These drains are more likely to clog and have a higher failure rate than proper rigid plumbing. Recommend replacement with rigid piping by a qualified handyman or plumber.

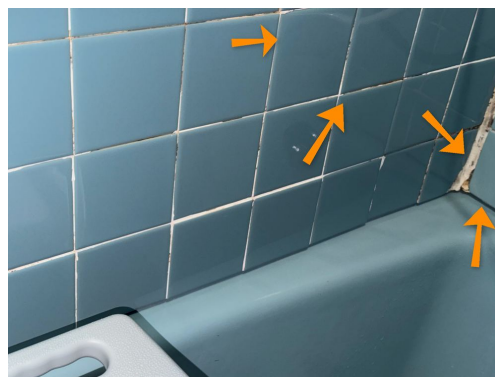
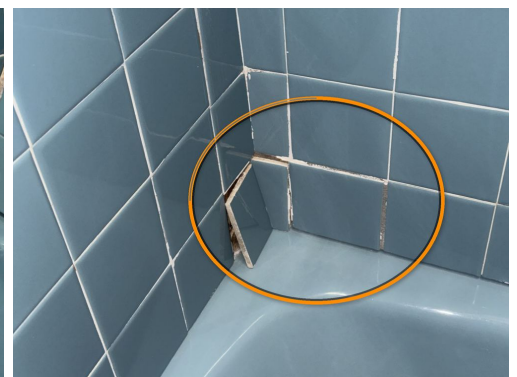
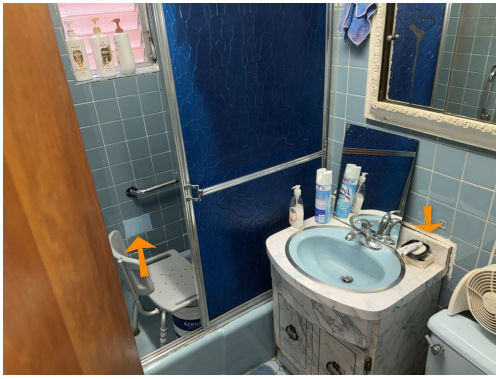
## 3.34 Bathroom

**Cracked and/or Damaged Tile**

Several broken & loose bathroom tiles in apartment 1. Must be repaired immediately and discontinue use of shower until repairs are made. Water will leak into basement causing further issues. Recommend repair by a qualified handyman or tile contractor.

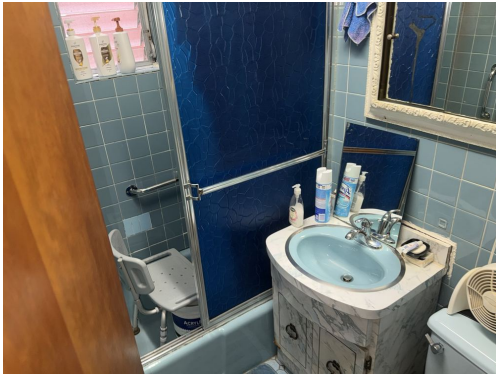
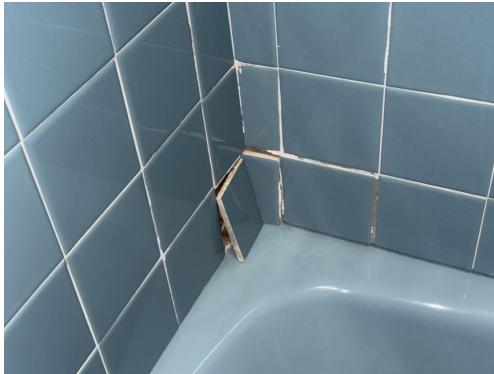
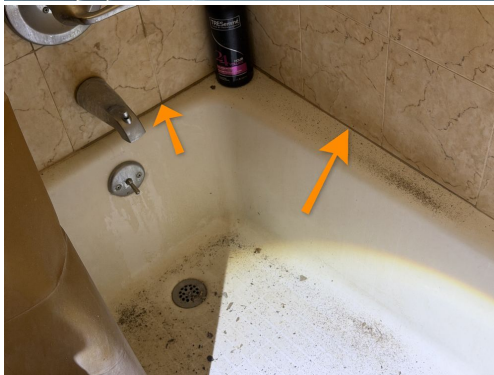
Evidence of moisture damage and inadequate caulking was observed in all bathrooms of the home. Recommend further evaluation and repair by a qualified contractor.

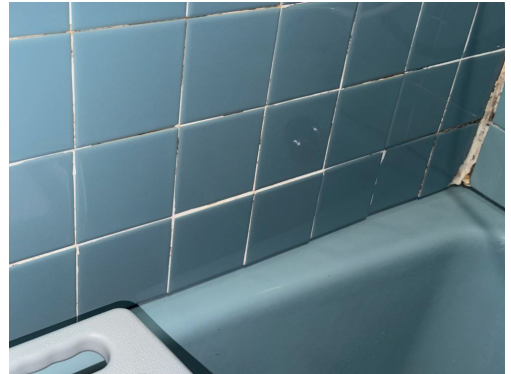
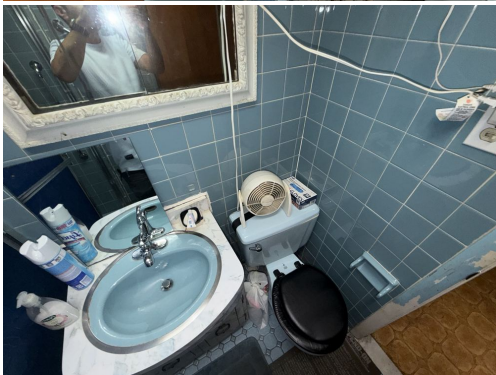
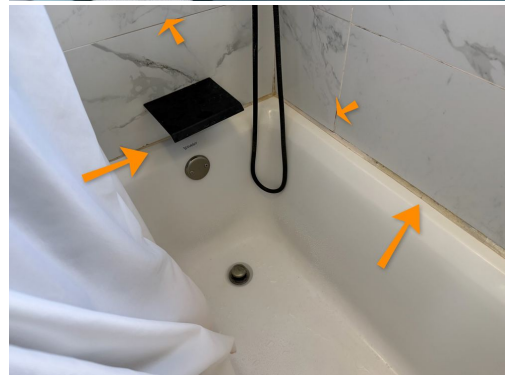
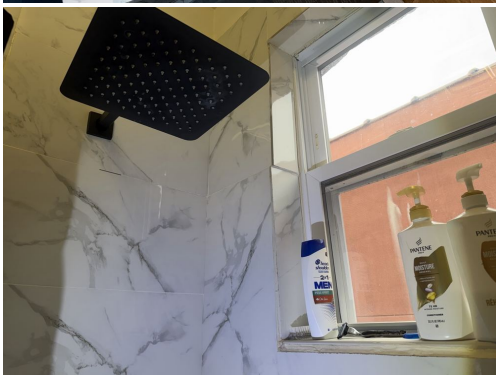
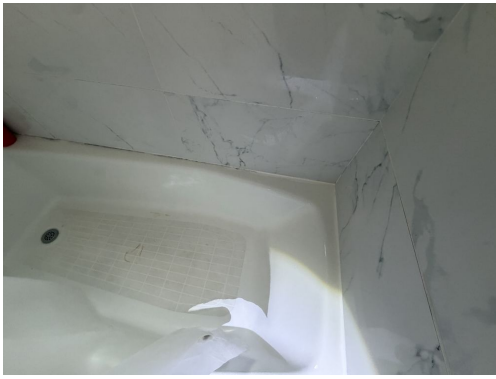
### 3.35 Bathroom

## Moisture Damage

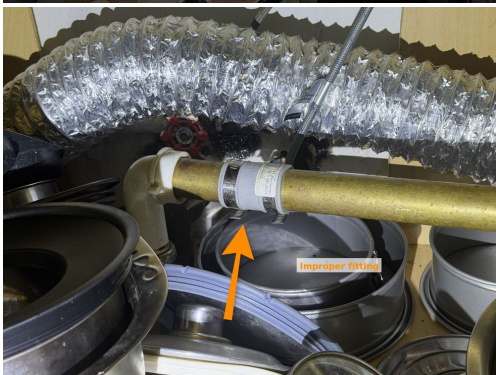
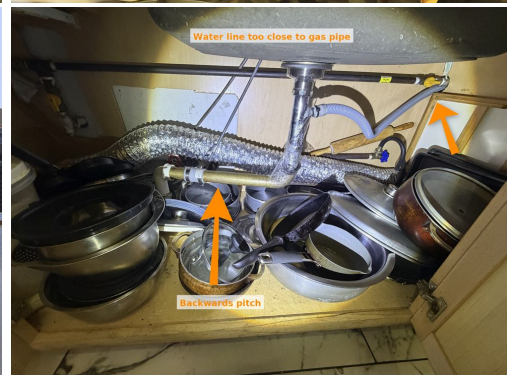
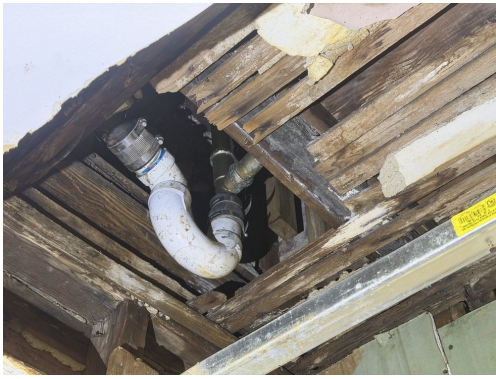
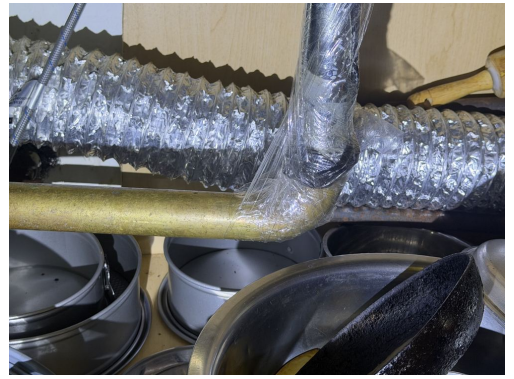
#### Improper Plumbing

Improper plumbing was observed. I recommend repair by a qualified plumber. Improper use of material. Backwards (upwards) pitch on plumbing lines, plastic wrap used to hold pipe together, gas line is touching water line, improper drain pipe. Recommend to have licensed plumber make necessary repairs immediately.

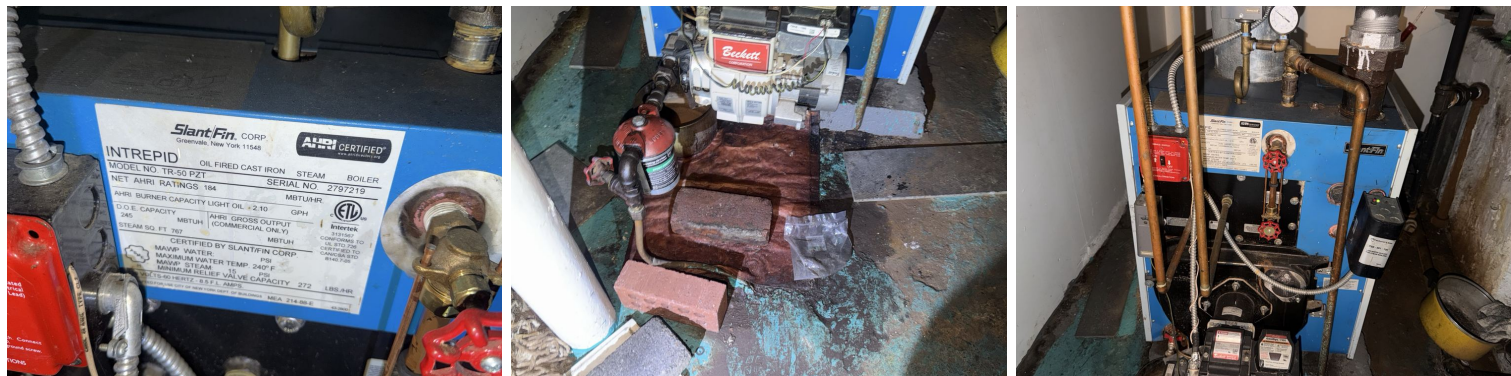
Heat Inoperable At Time of Inspection

The heat was inoperable at the time of inspection. I recommend inquiring with seller and requesting successful demonstration of the heat, or arranging a re-inspection when heating is functioning prior to closing.

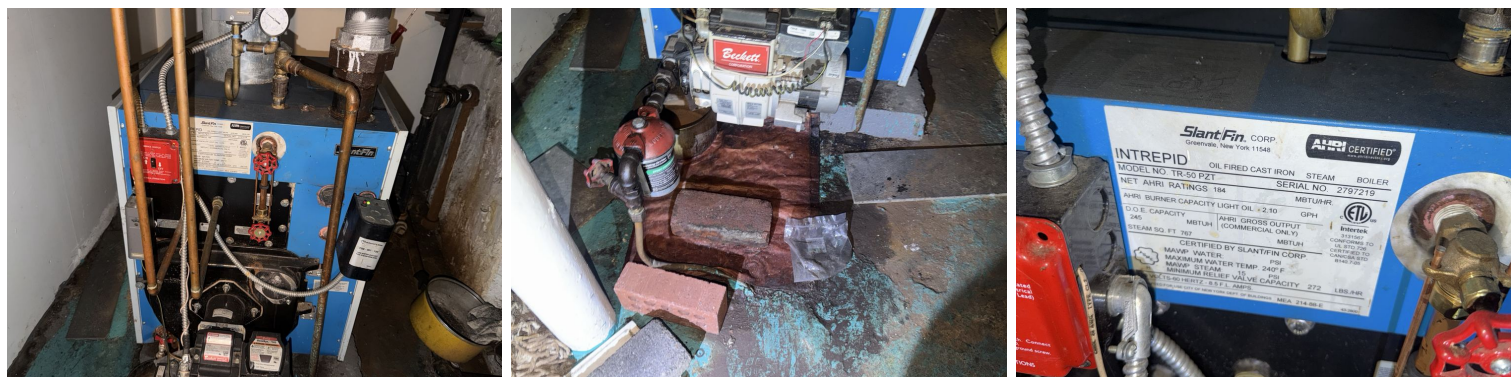
4.2 Equipment

Oil fired steam boiler installed in the basement. Unable to test heat at time of inspection due to high indoor temperature. Boiler was leaking oil at the time of inspection. Strongly recommend to discontinue use of boiler until leak has been corrected & spilled oil has been properly cleaned.

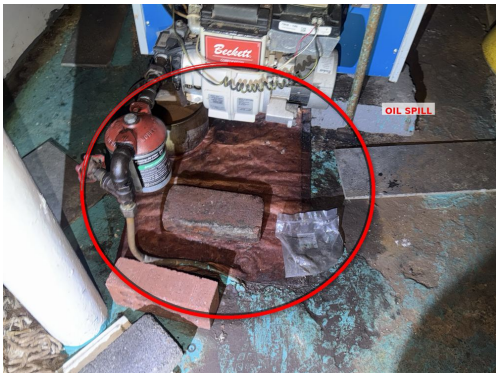
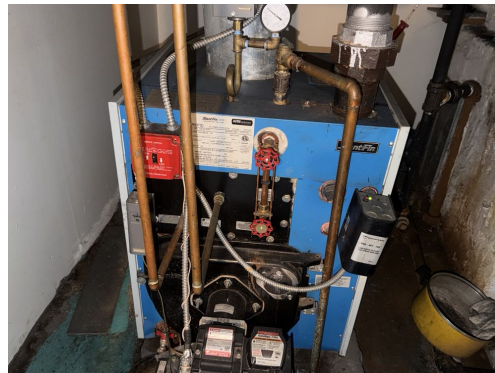
There was an oil leak observed on the heating appliance plumbing. I recommend repair by a qualified HVAC contractor & have the oil cleaned by appropriate contractor.

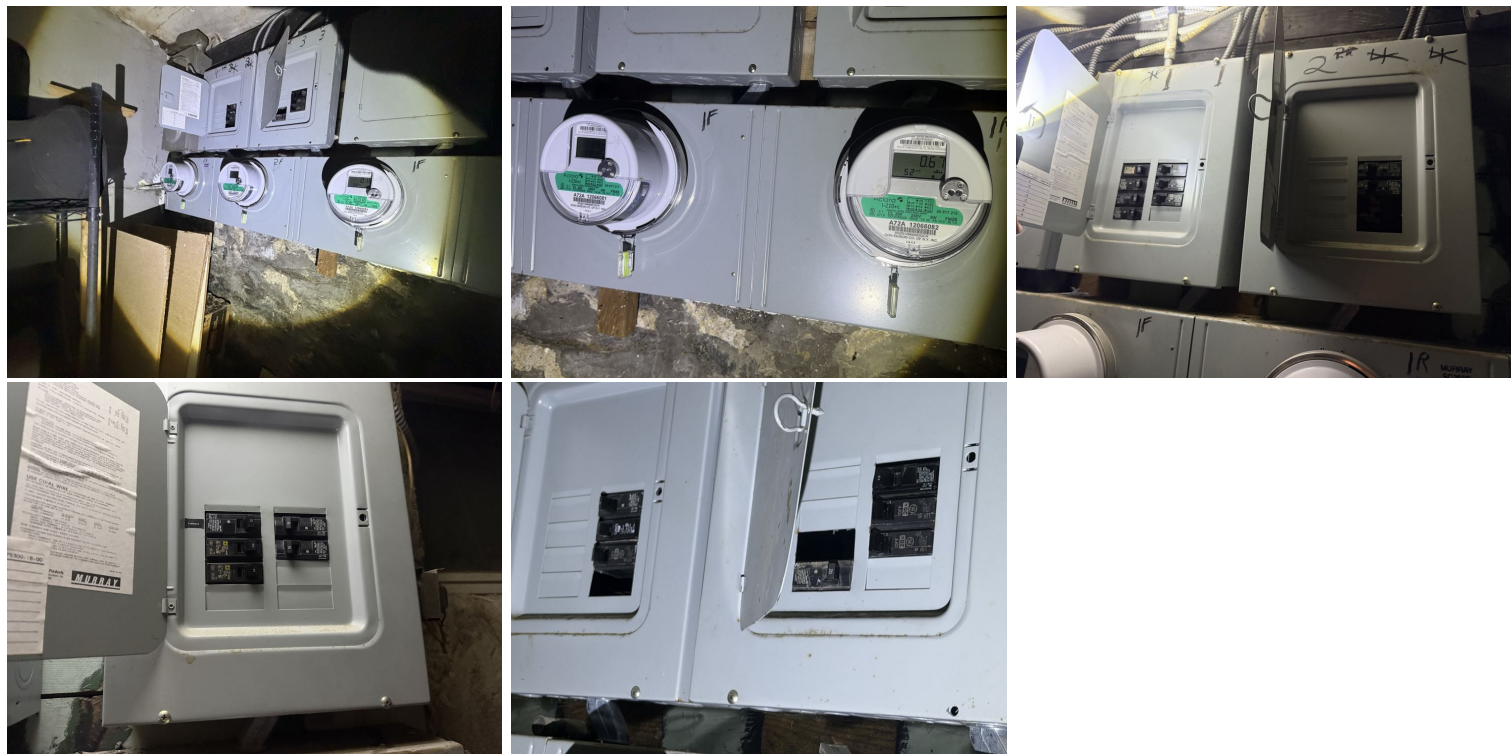
7.1 Main Electrical Panel(s) (Load Center)  
Main Panel Location: Basement

Overhead electrical service with 5 electric meters & main panels in the basement. Panels had openings which must be closed immediately. Safety hazard noted.

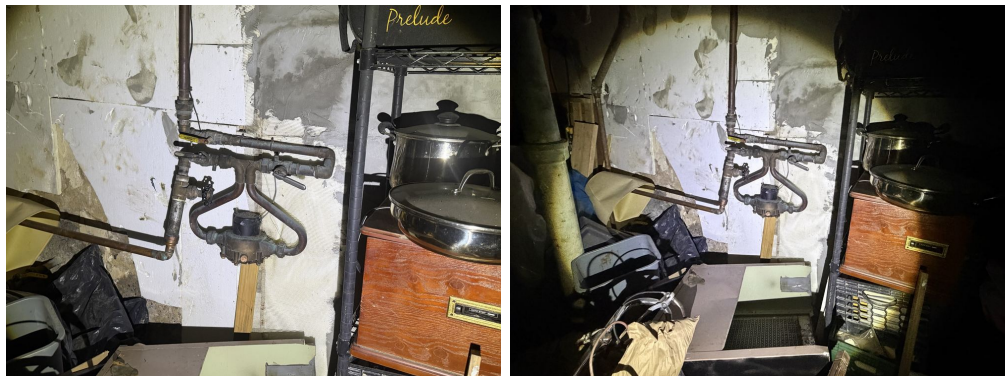
Water Source: Public

Water meter in the front of the basement.

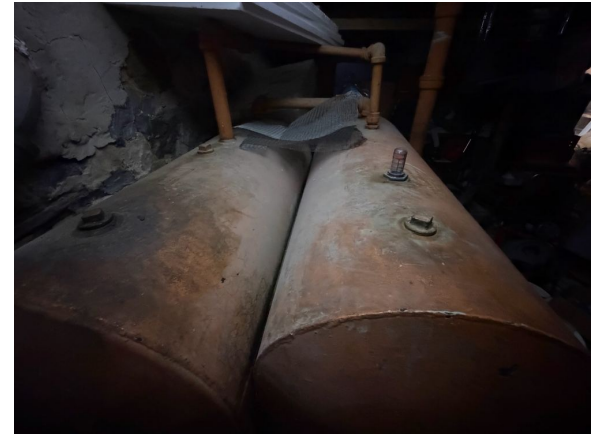
#### Oil Storage Tank

2 x 275 gallon tandem oil tanks installed in the basement. Oil fill line located on the exterior left side of the home. The oil storage tank was inspected looking for defects such as rust, corrosion, leaks, improper installation, and overall condition. The tank was observed to be satisfactory with no reportable defects or deficiencies at the time of inspection unless otherwise noted in this report.

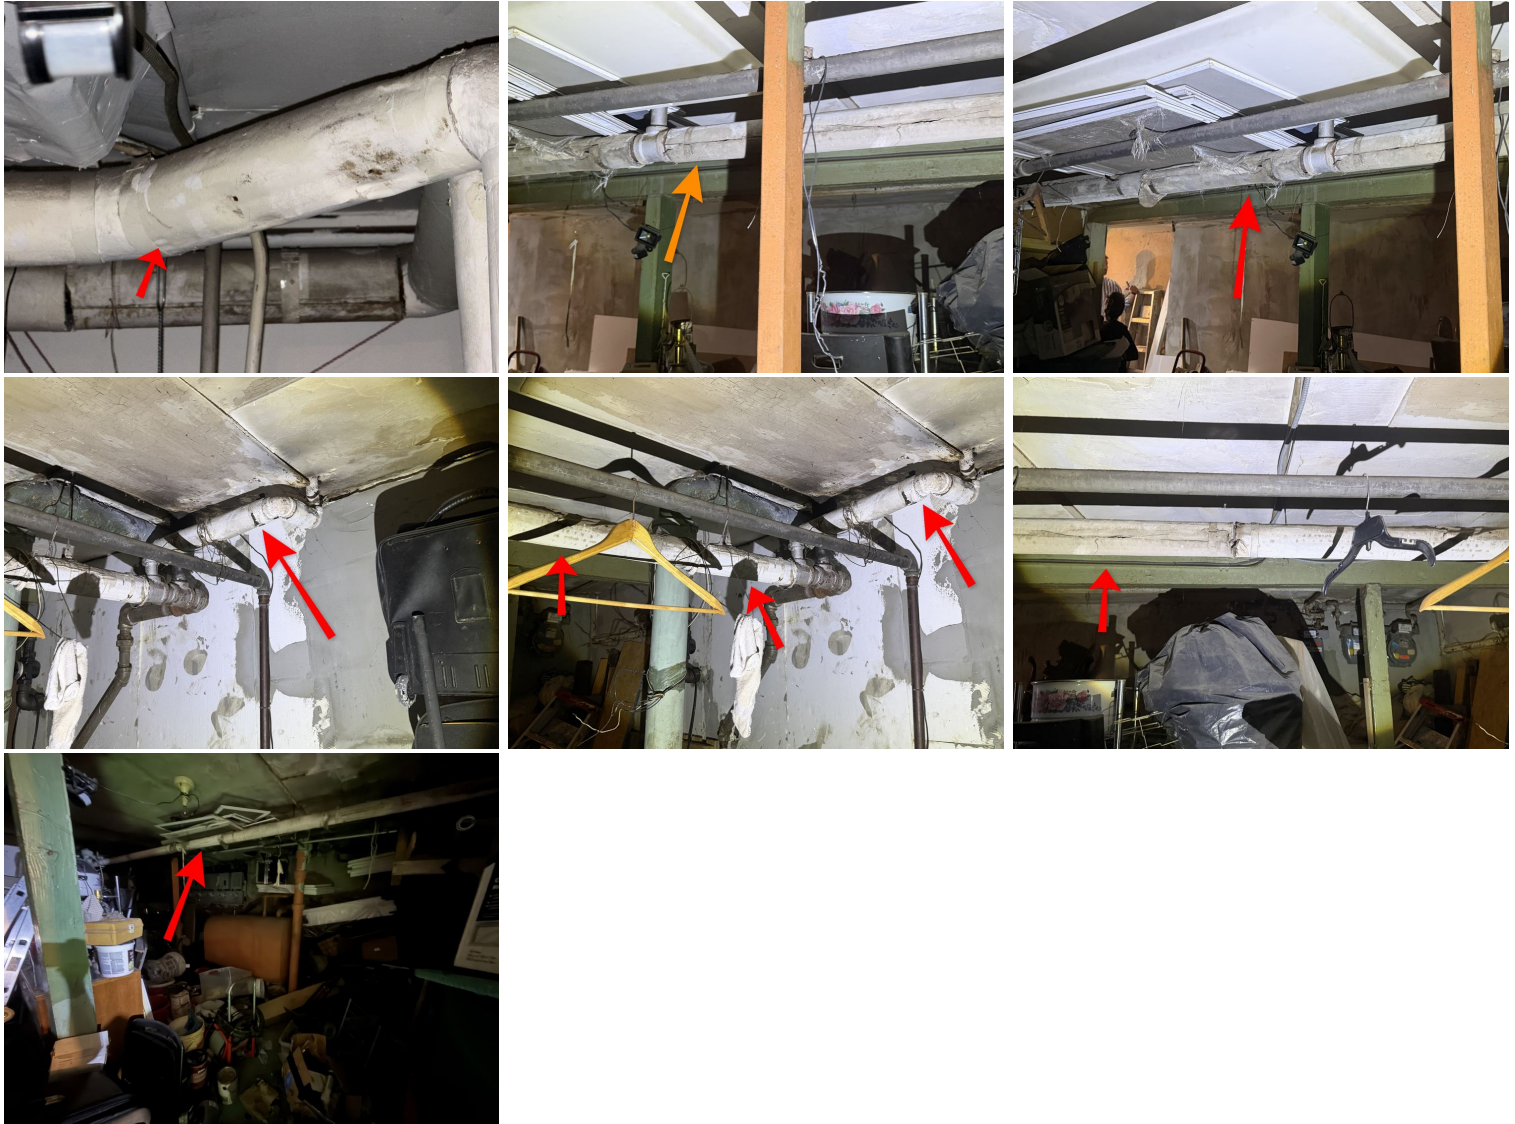
## 8.15 Water Supply, Distribution Systems &amp; Fixtures

**Possible Asbestos-like Material Observed**

Asbestos can be a health hazard to remove and often difficult or expensive to dispose of. Do not disturb, attempt to remove it, or cut, scrape or drill it as breathing or coming into contact with the dust and fibers can cause serious adverse health problems such as mesothelioma.

I recommend further evaluation by a qualified asbestos remediation contractor.

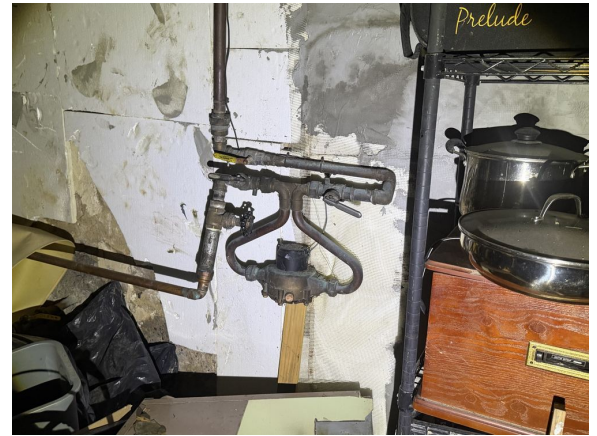
## 8.16 Water Supply, Distribution Systems &amp; Fixtures

**Possible Lead Pipes Observed**

One or more pipes in the home were observed to be lead. Lead can have serious effects. Occupants can absorb lead through the water they drink. Lead poisoning can cause kidney damage and also reproductive problems, which can lead to infertility. It can affect the nervous system and the ability to learn in children. Recommend evaluation by a qualified professional.

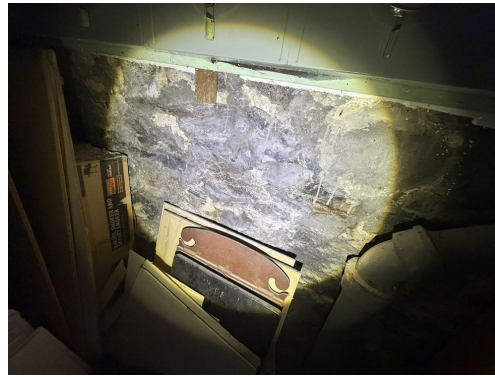
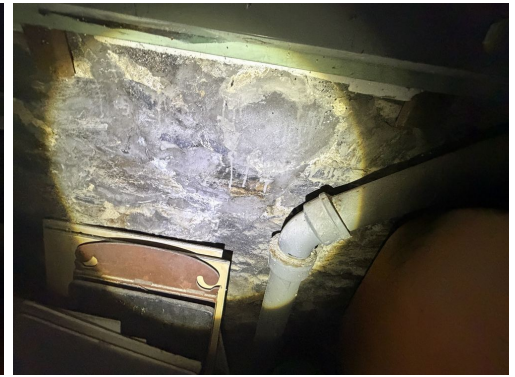
Efflorescence and/or evidence of moisture intrusion was noted on basement surfaces. This indicates moisture intrusion and can cause damage to the home, and/or lead to mold growth. This is commonly caused by poor or negative grade and roof drainage system inadequacy.

Recommend a qualified contractor identify source of moisture and remediate as necessary.

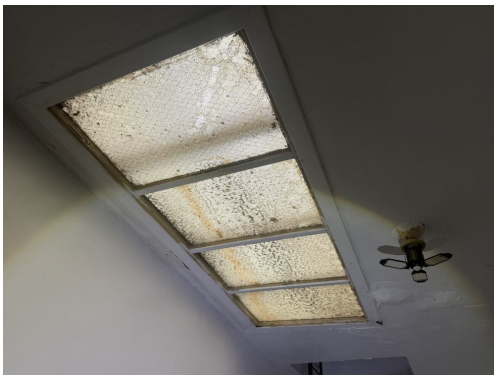
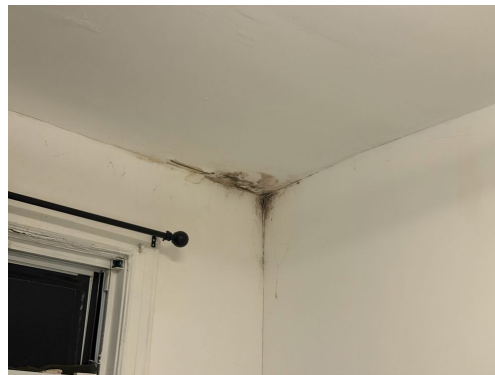
## 9.5 Basements & Crawlspaces

### Possible Mold-Like Substance

There were areas of the basement and or crawl space that were observed to have what appears to be a possible mold-like substance. I recommend further evaluation with remediation as deemed necessary by a qualified professional.

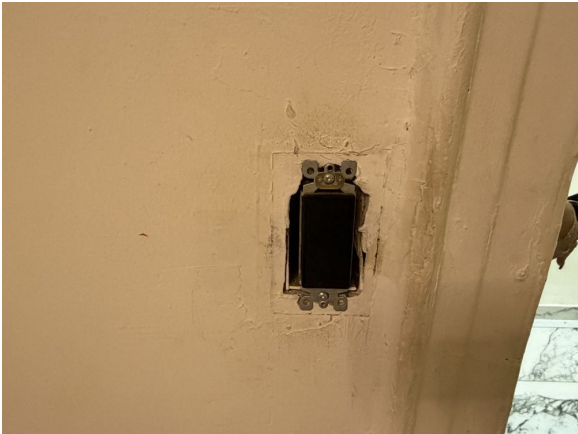
Numerous electrical receptacle or switch boxes were observed to be missing cover plates. This is a safety hazard. I recommend further evaluation by a qualified contractor with repairs made as deemed necessary.

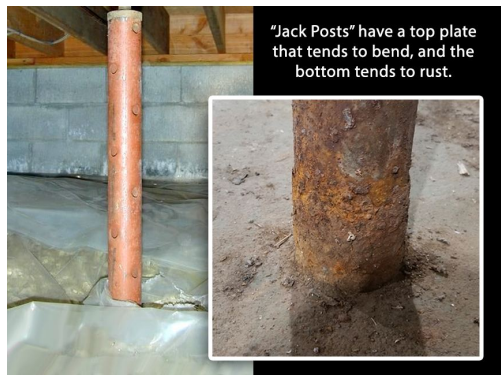
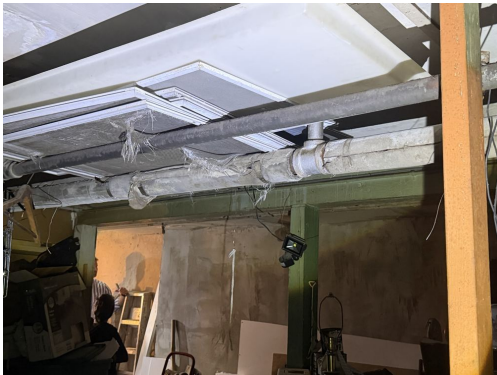
These are not intended for permanent, long-term use as they are thin-walled columns. The bottoms tend to rust and can crush, causing settling of the structure, and the top plates tend to bend allowing the threaded pin to protrude into the beams or joists.

"Jack Posts" have a top plate that tends to bend, and the bottom tends to rust.

"Jack Post" columns have a metal top plate that tends to bend, and the threaded pin will begin to push into the beam.

I recommend that a qualified contractor replace these types of temporary supports with permanent support posts such as pressure treated wood posts or proper steel posts that are designed for permanent installation.

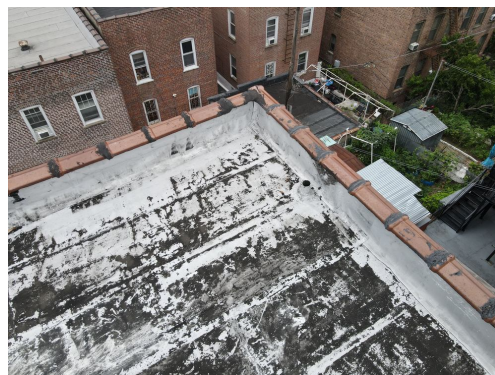
Reportable deficiencies were present at the time of inspection and will be noted in this report.

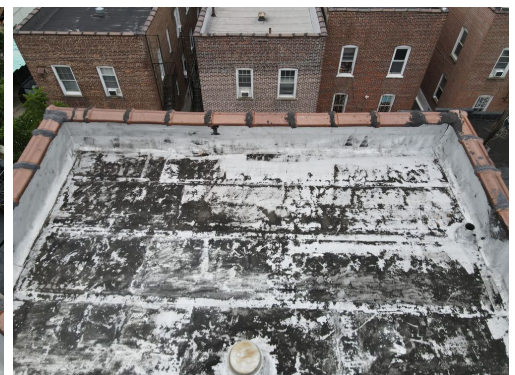
#### Roof Penetrations & Flashings - Deficiencies Present

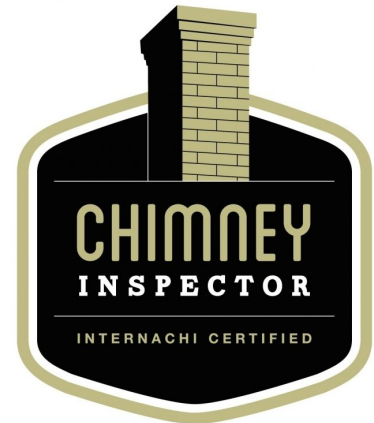
The chimney(s) were inspected by an InterNACHI Certified Chimney Inspector looking for an adequate and functioning chimney crown, the condition of the masonry and flashings, the condition of visible portions of the flue liner(s), etc.
