## Expert NY Inspections LLC

# KINCAID RESIDENTIAL INSPECTION REPORT

**123 Sample Street**

**1/15/2024 10:00AM**

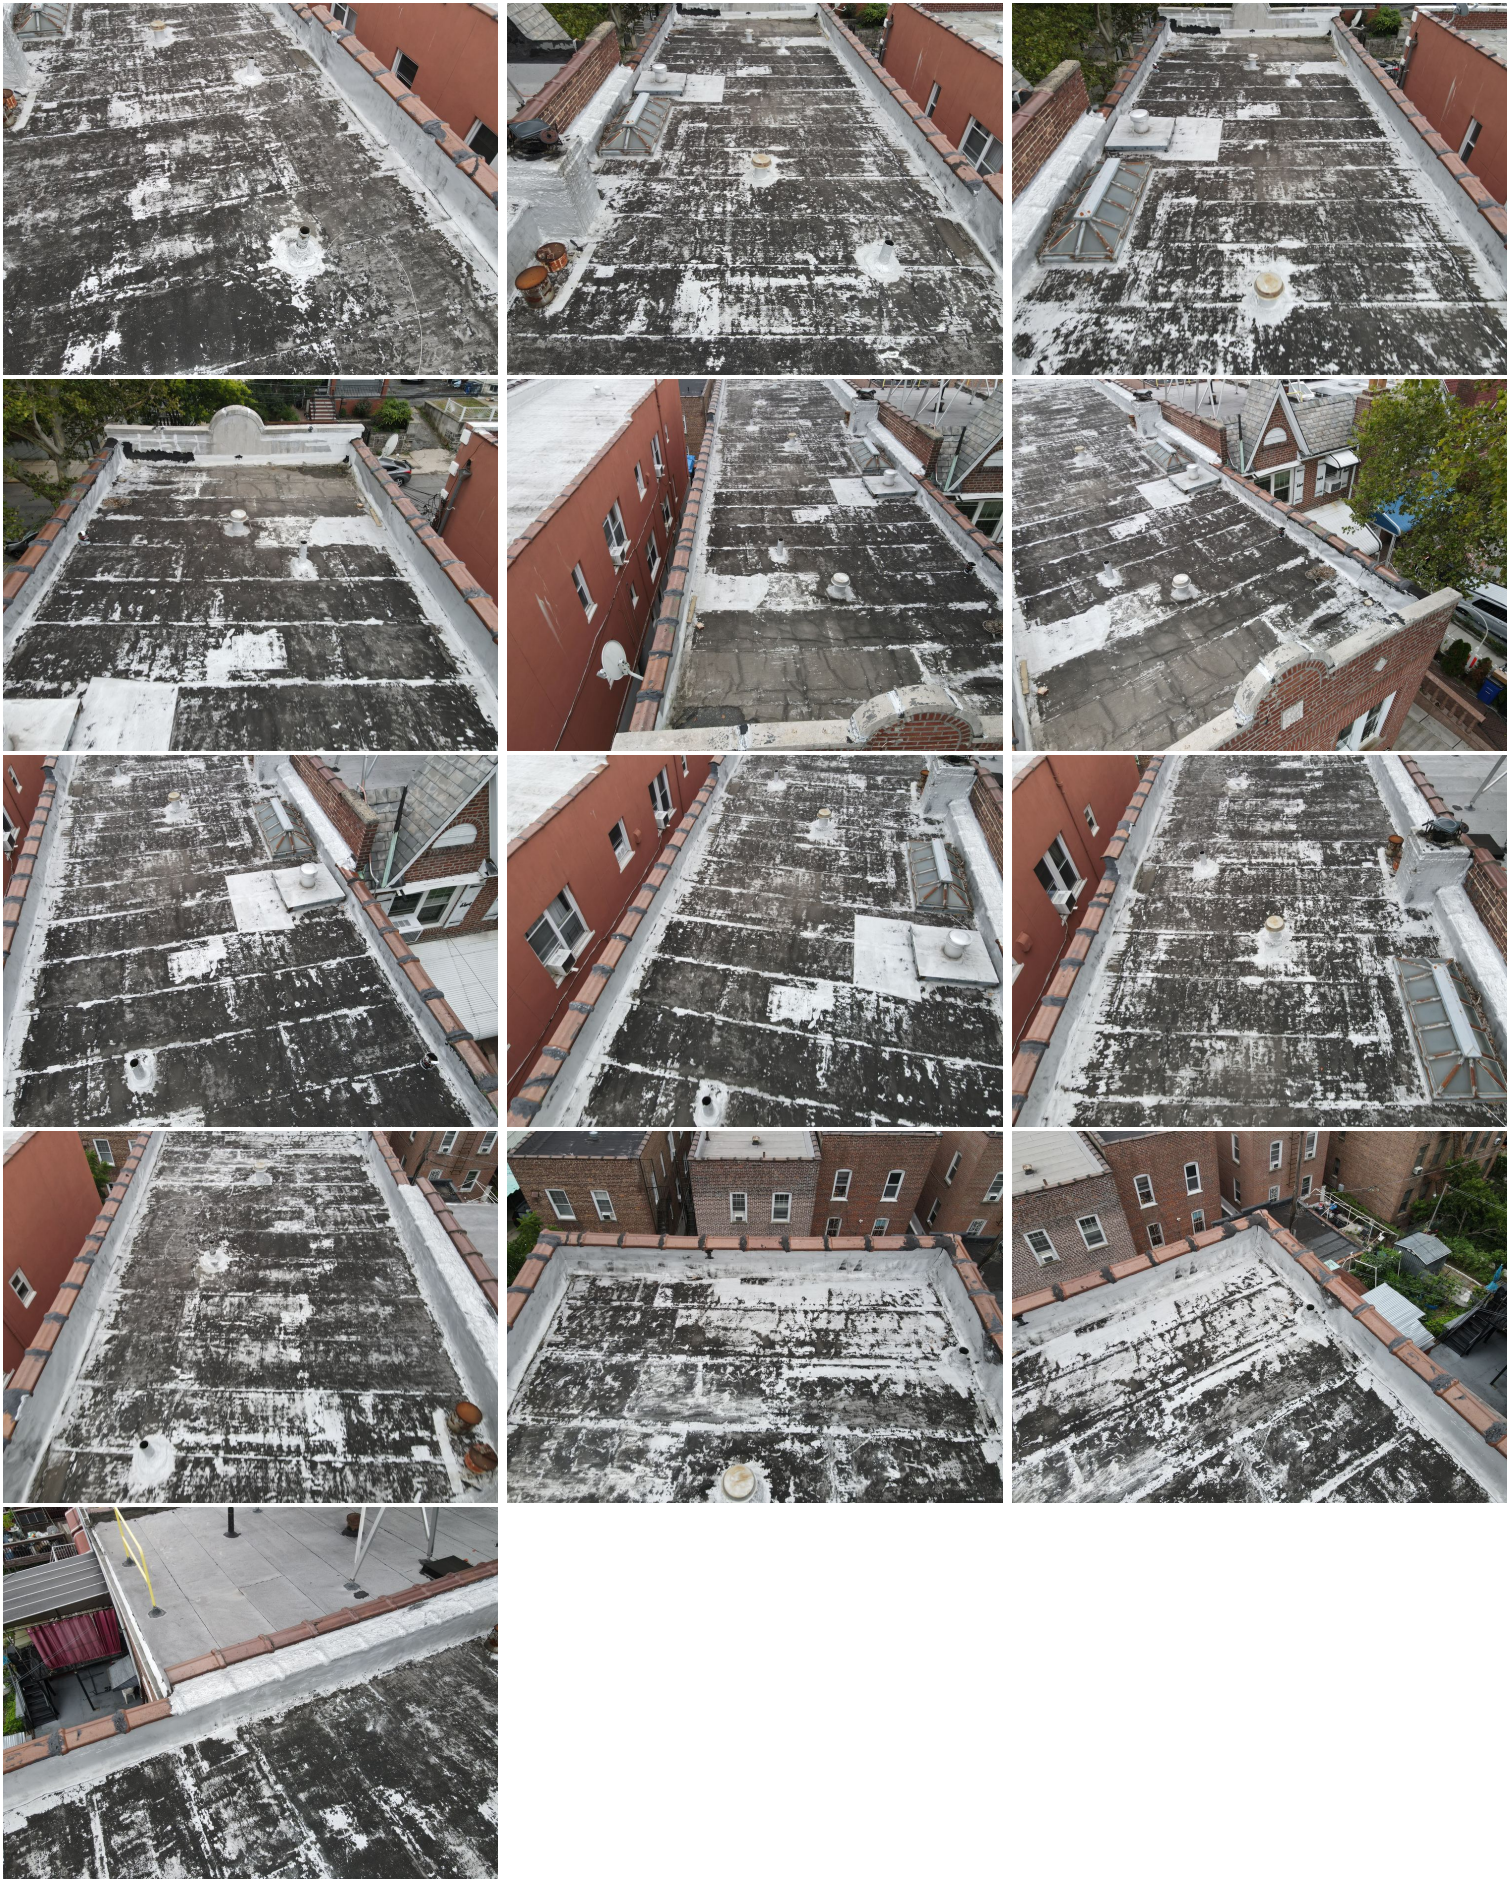
The roof covering was observed to be in poor condition. It is the opinion of the inspector that the roof covering is at or beyond its useful life expectancy and it is recommended that the roof covering be replaced as soon as possible.

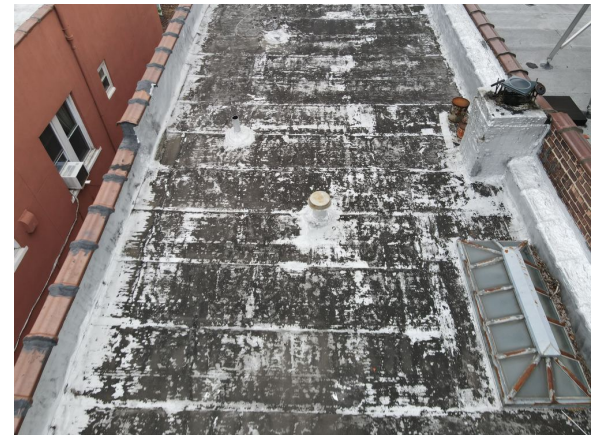
**Location:** Photo from CYA Bank

**Kickout/Diverter Flashing - Inadequate/Missing**

Sidewall flashing was inadequate or not present at one or more areas of the roof. This can lead to deterioration of the siding, or moisture intrusion at the sidewall. Recommend repair by a qualified roofing contractor.

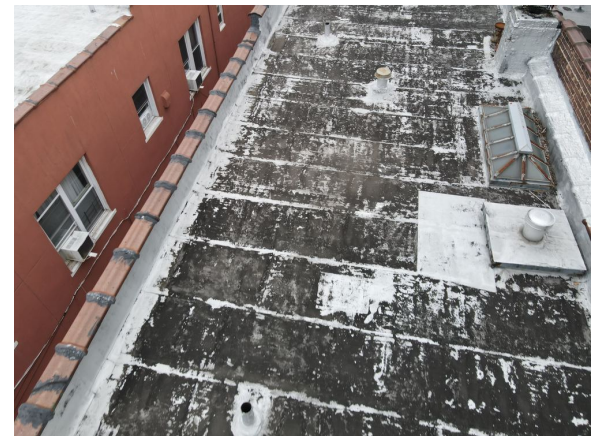
## 14.15 Skylights

**Chimney Flashing Not Present**

Chimney flashing not present. Typically there should be flashing or step flashing, and counter-flashing. This condition may allow moisture intrusion around the chimney. Recommend repair by a qualified roofing contractor. Significant rust observed on the skylight.
